# Case Study

Sector: Transport  
Project: Mersey Tunnel  
Location: North West of England

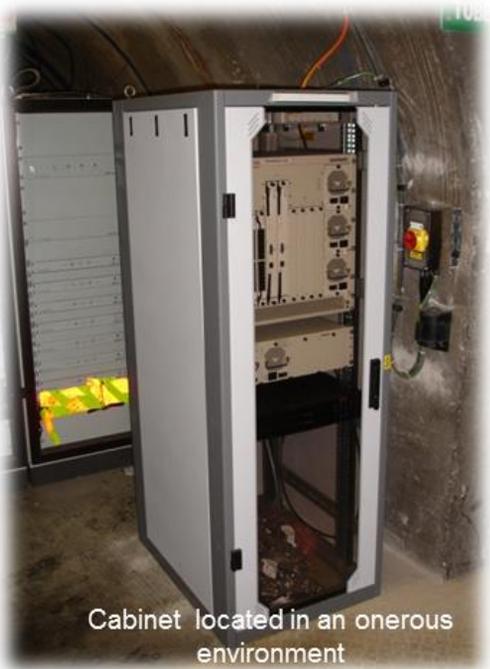
Cabinet located in an onerous environment

The IP65 cabinets were equipped with a number of features that allow them to operate in extremely onerous environments. When designing the product we took into consideration such factors as:

The cabinets were located in the area below the roadway. This area experiences ongoing flooding coming from the underground water streams. Despite the tunnel pump system regulating the water levels we still needed to ensure the cabinet plinths and cable seals would provide secure protection against these conditions.

The water accessing the tunnel grounds can be fresh water or salt laden water. This required extra protection in a form of a special paint coat. The stainless steel cabinet construction has been layered with specially designed high performance paint. Our proven external powder coating system consists of a number of different processes which when applied to strict guidelines provide adequate protection for the most challenging environment. The paint process developed by Rainford Solutions is a result of years of experience of designing cabinets for various corrosive environments worldwide.

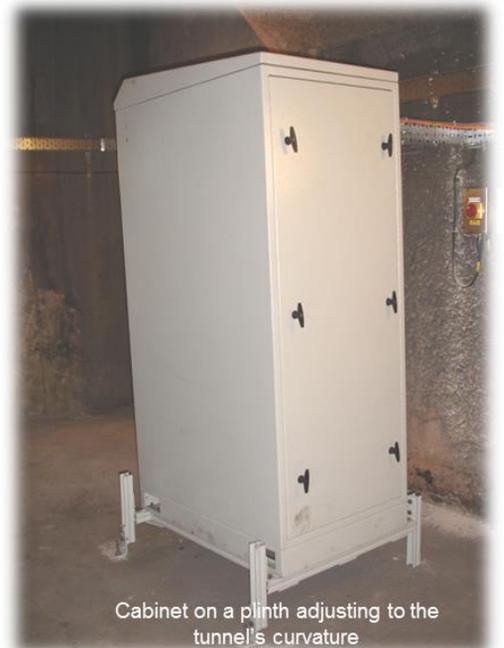
Cabinet on a plinth adjusting to the tunnel's curvature

The naturally curved tunnel surface required the cabinet plinth to have features which allowed the cabinets to be installed at various locations. This adaptation allowed keeping the cabinet in correctly levelled, vertical position suitable for the equipment.
